# WHAT CAUSED TOWER MALFUNCTIONS IN THE LAST 50 YEARS?

H. Z. KISTER

Fluor, Aliso Viejo, CA, USA

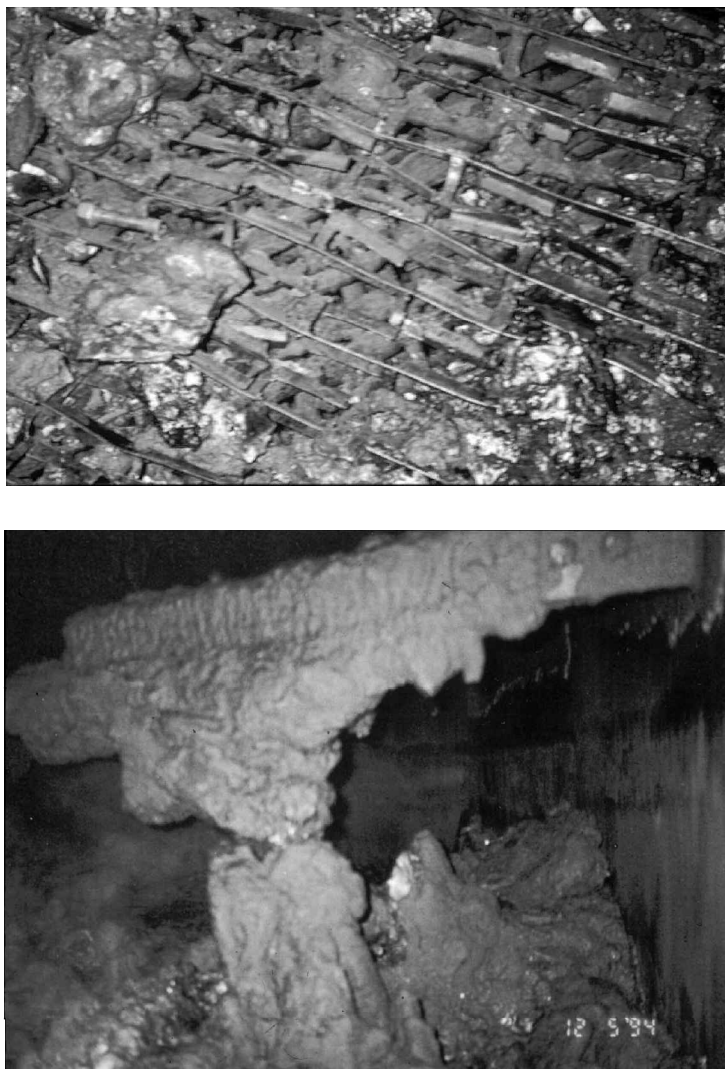
Figure 1. Grid packing is one of the most open and most fouling-resistant packing in the industry, yet it is no match for severe coking in a refinery vacuum tower. The coke is shown to fill the open spaces and to form stalagmites and stalagmites at the spray nozzle distributor.

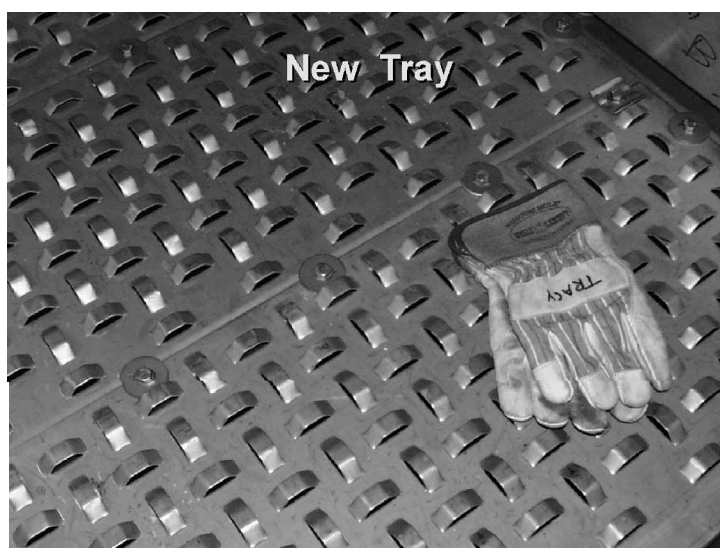
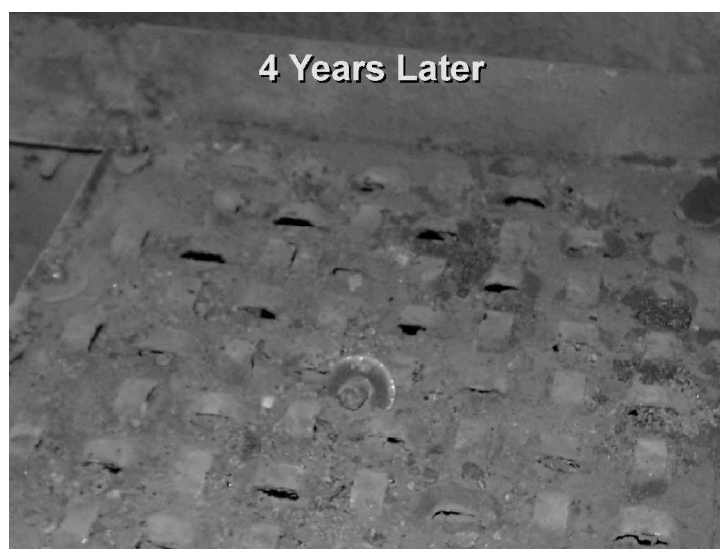
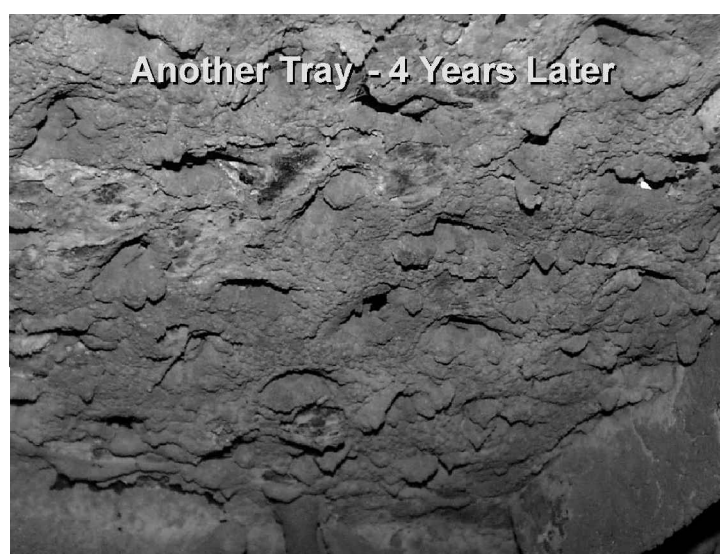
*Figure 2.* Even fouling-resistant trays are not immune to plugging under severe fouling conditions. These photos show active areas of one of the more fouling-resistant tray types in the industry plug up over a 4 year run. The plugging is believed to have been caused by severe salting out, a common cause of plugging.

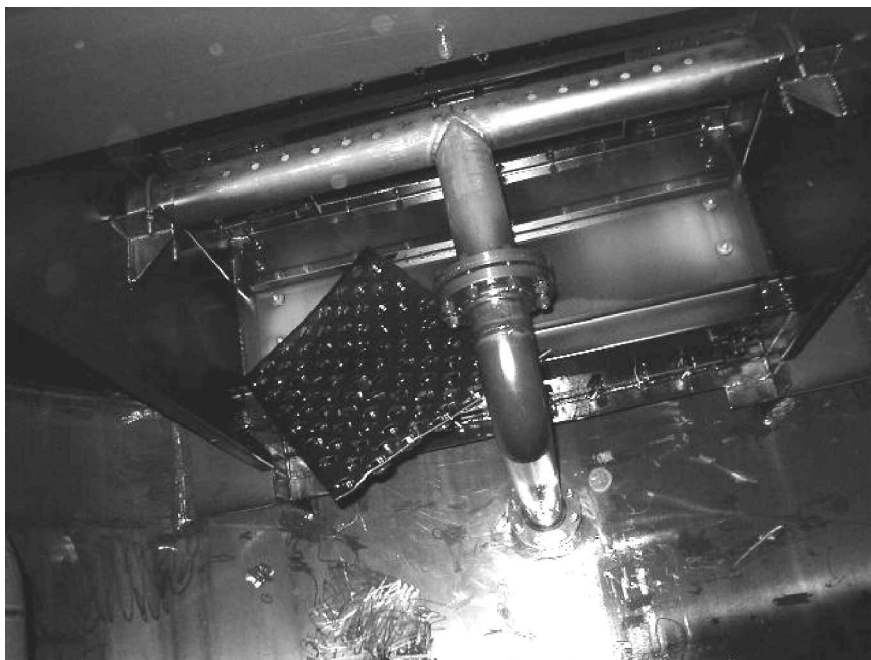
Figure 3. A displaced panel on the bottom tray in a refinery crude tower, the work of a water-induced pressure surge. Water-induced pressure surges can cause more severe damage; Amoco (1984a) has illustrations. The tower base is a common troublespot.

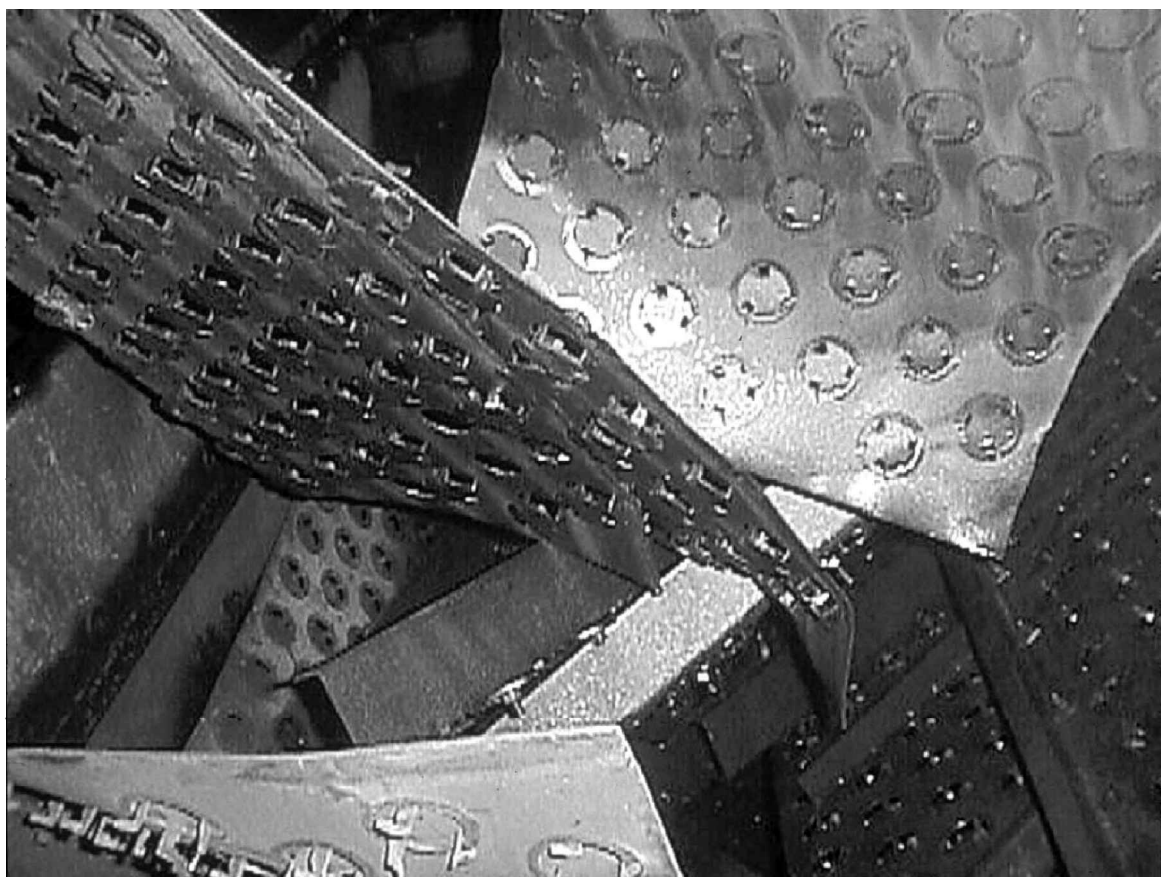
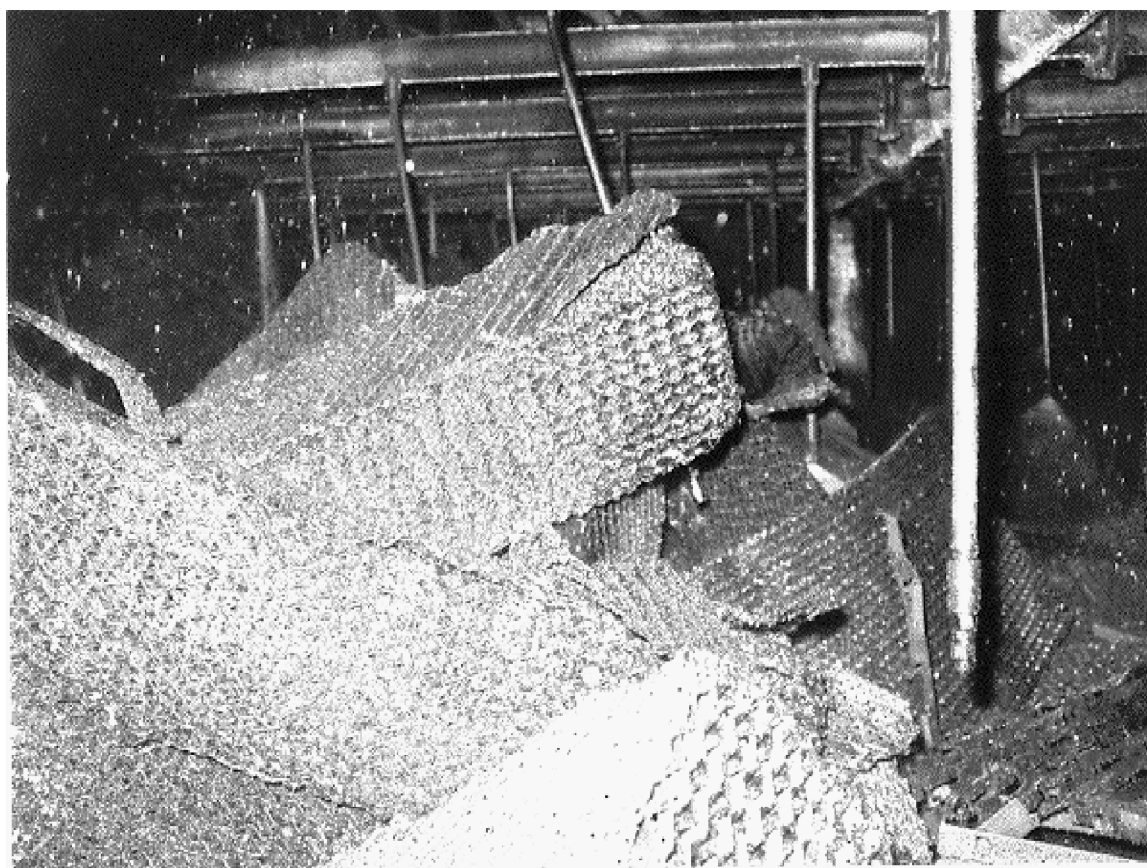
*Figure 4.* Liquid level rising above the reboiler return or vapor feed entry is one of the most common sources of malfunctions, including tray and packing damage, as shown. The author's experience is that these high liquid levels cause tray and packing damage even more frequently than the malfunctions survey suggests.

The corrective measures to prevent excessive tower base level are those recommended by Ellingsen (1986): reliable level monitoring, often with redundant instrumentation, and good sump design. Based on the current survey, the author adds avoiding excessive kettle reboiler pressure drop to that list.

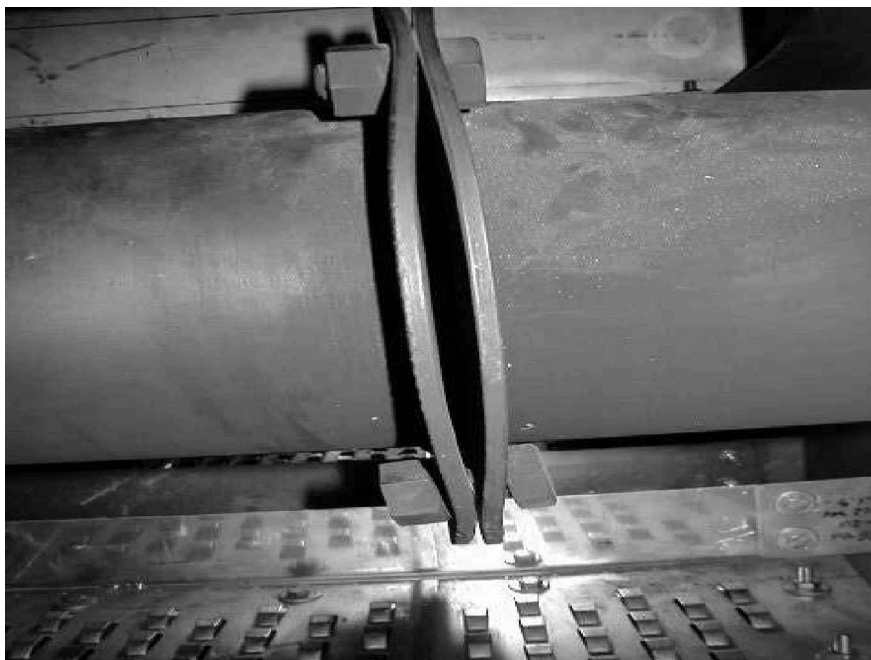
Figure 5. Damage often results from insufficient mechanical resistance. Flat-plate flanges on internal pipes, such as those leading to feed and reflux distributors, are weak and tend to spread apart. Gasketed raised face flanges of the appropriate pressure ratings should be used.

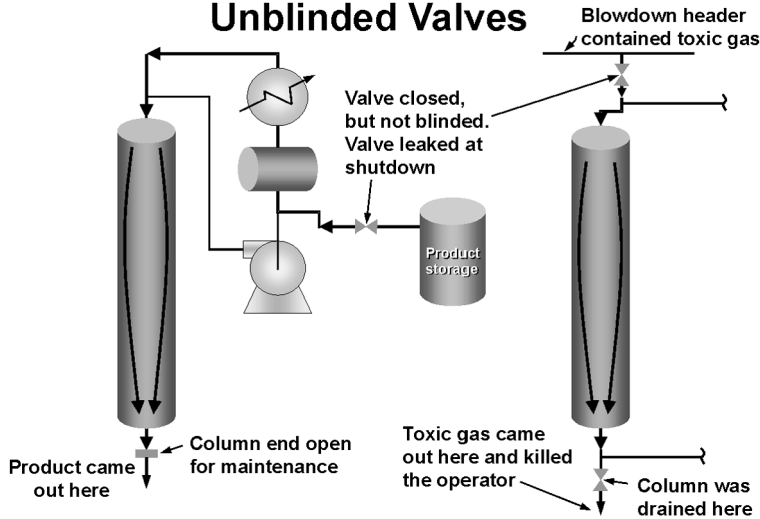
Cases 1108, 1109 - Reverse Flow Thru Unblinded Valves

Figure 6. Two case studies in which reverse flow through shut but unblinded isolation valves led to chemicals leaking into the tower during a turnaround. In one case (left), the leaking valve allowed product from storage to back-flow into the depressured tower, coming out of the bottom end that was open for maintenance. In the second (right), toxic gas from the blowdown header back-flowed through the leaking valve into the depressured tower, coming out the tower bottom, where it killed an operator draining the tower. These cases emphasize the importance of following good blinding/unblinding practices. Based on Kletz (1988).

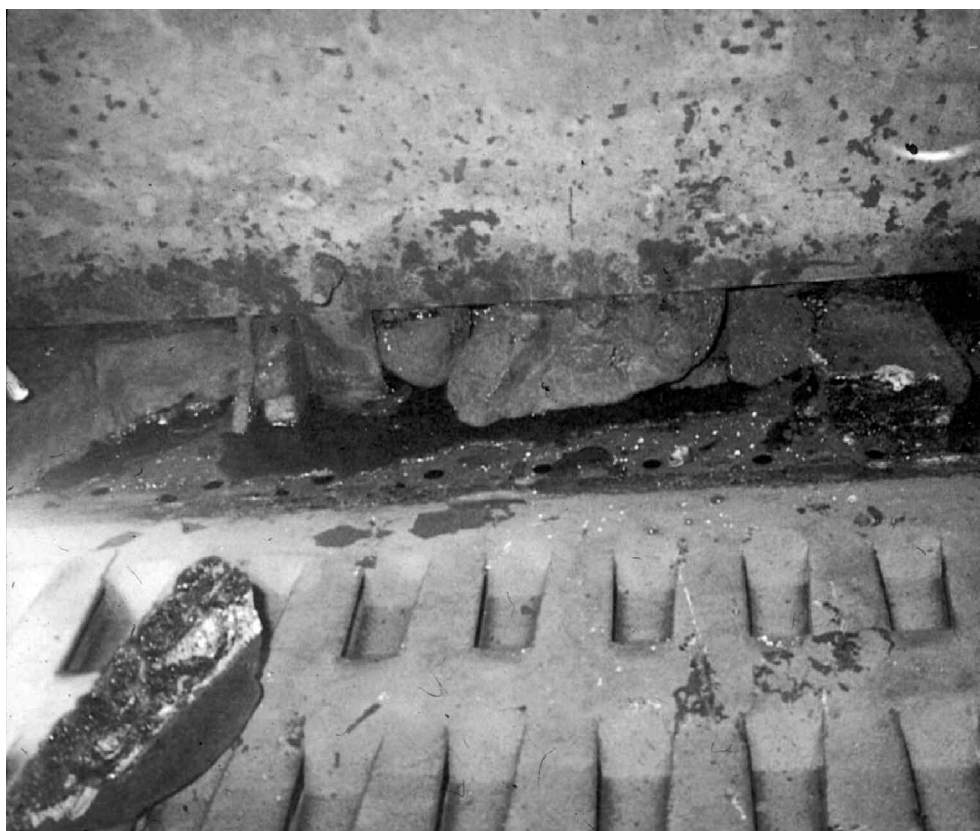
Figure 7. Incorrect assembly of tray panels is one of the most common assembly mishaps. Here panels of fixed valve trays were installed upside down. Also note the rocks in the downcomer; fouling was also a major issue in this tower. This diagram highlights the importance of inspecting tray and packing installation.

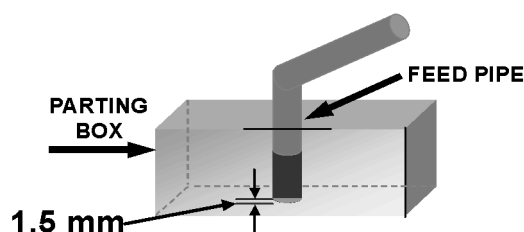
## Case 956 - The Overlong Feed Pipe

Figure 8. Poor fabrication and installation of packed tower distributors is one of the most common assembly mishaps and also one of the most common packing distributor malfunctions. Feeding packing distributors has also been a common source of problems. Here the feed pipe into a parting box clears the floor of the box by 1.5 mm, leaving a tiny crack for liquid exit. This diagram highlights the importance of tower inspection following construction or modifications. Based on Olsson (1999).

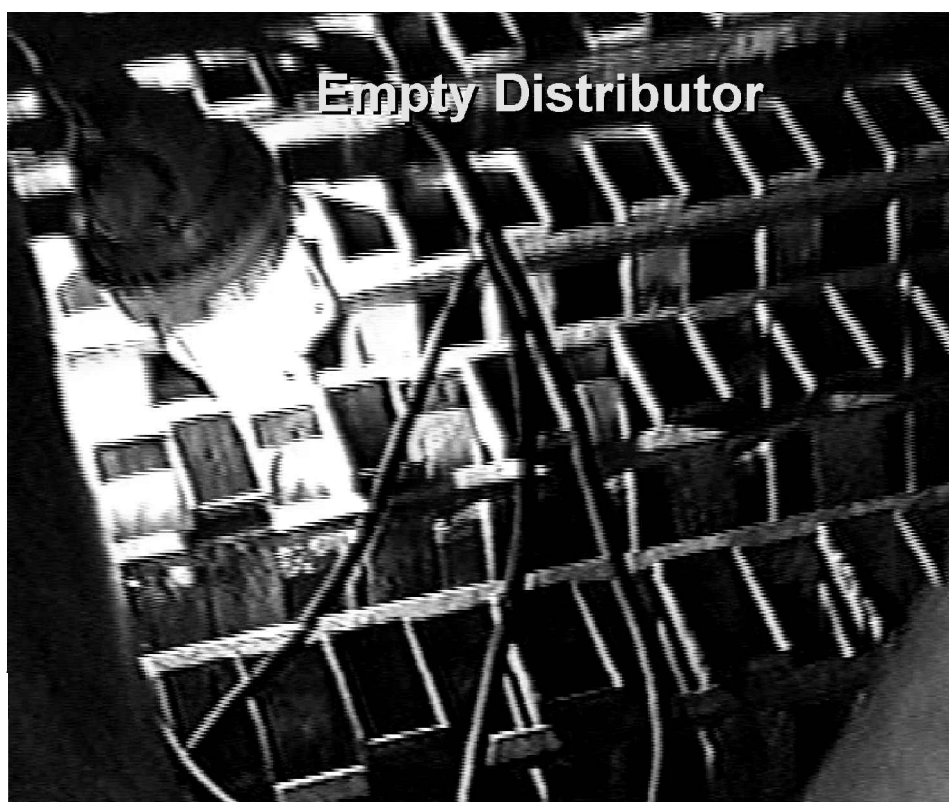
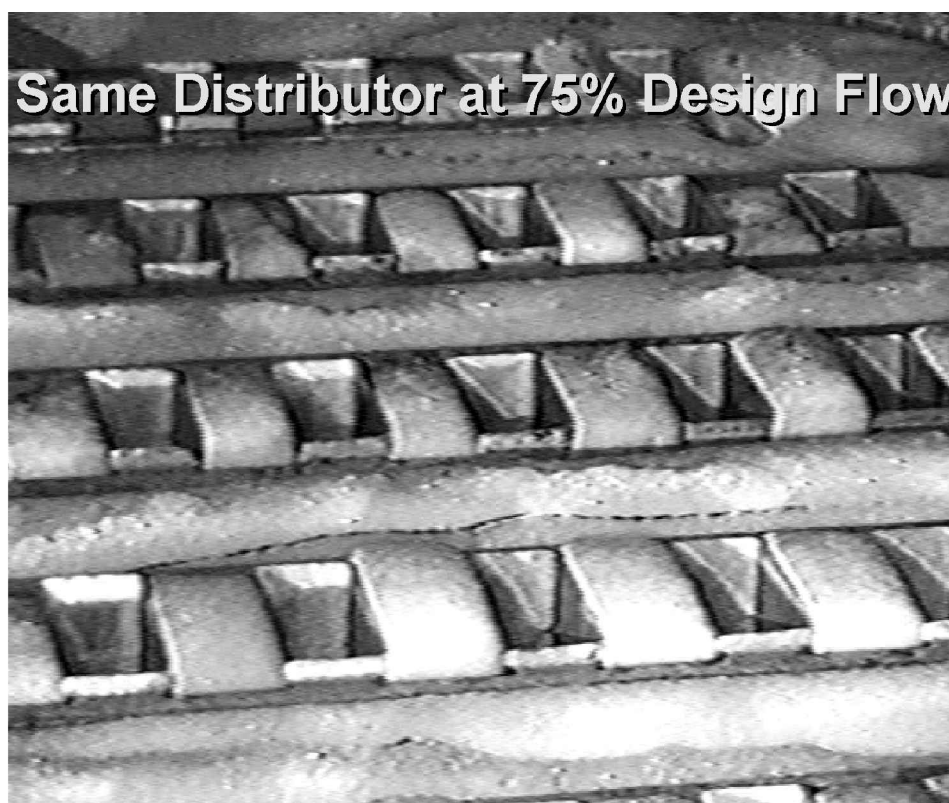
*Figure 9.* Next to plugging, overflow is the most common packing distributor malfunction. Here a packing distributor is water-tested *in-situ* during the turnaround (after cleaning). At 75% of the design liquid flow, the water is seen to reach the top of the vapor chimneys. This diagram highlights the importance of water-testing distributors.

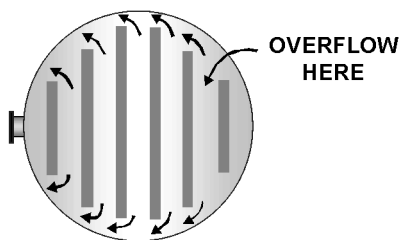
### Case 883 - High Hydraulic Gradient Causing Overflow into Chimneys

Figure 10. Excessive hydraulic gradients have been the cause of overflows both in liquid distributors and on intermediate draw trays. Here an excessive hydraulic gradient led to liquid overflow down the vapor chimneys of a total draw tray. Based on Kister *et al.* (2001).
