CASE STUDY

Flare Headers – What You Don't Know, Could Hurt You

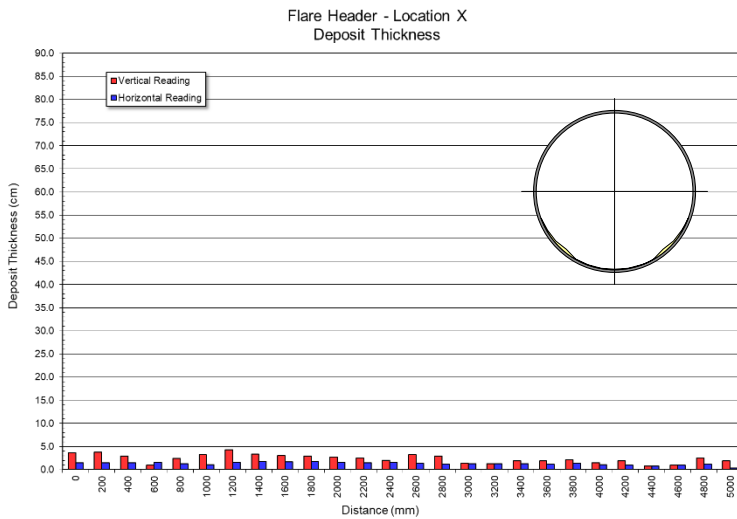
Most of the flare header piping appeared to be clear of debris with little deposited material identified. Measurements taken in both the vertical and horizontal axis are presented to scale with the pipe diameter for a rapid visual assessment by the customer. This 5-meter section of piping indicated less than 50 mm of debris in the bottom of the pipe.

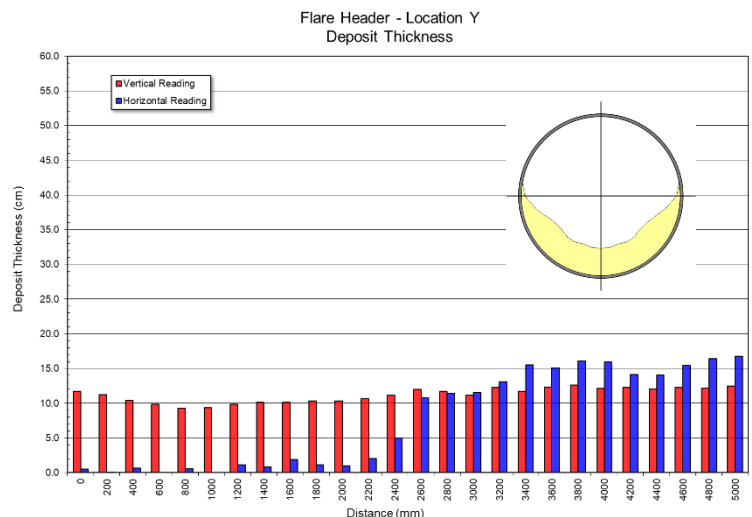
Several sections of the flare header contained higher deposits of concern. A 5-meter length close to the process unit showed a consistent deposit in the bottom of the pipe (red data). This thickness was equivalent to 15% - 20% of the pipe diameter.

Horizontal readings (blue data) over this same interval indicated no deposits crossing the center of the piping until midway through the scanning distance. The horizontal thickness started to increase indicating that the deposit profile had climbed past the midpoint of the piping along the wall.

A rotational scan was performed at this location to verify the results by producing a profile of the deposit inside the pipe.

- The customer received the information necessary to decide which sections of piping would be removed during the turnaround.
- Pipe sections could be fabricated prior to the shutdown with equipment, maintenance and safety crews scheduled appropriately.
- Replacement time was minimized, reducing the overall shutdown time and costs for the customer.
