CASE STUDY

Identifying Damaged Trays in an Amine Regenerator Tower

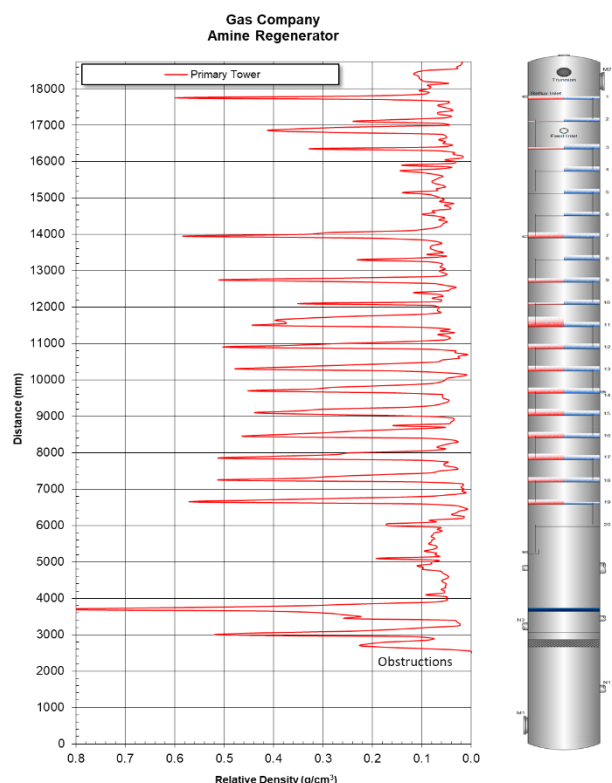
A non-invasive Gamma Scan was completed on the tower under operating conditions. The scanning crew saw the graphical results in real time and could immediately see that several trays were not in position or were damaged. Trays 2 to 6, 8, 10 and 20 showed irregular gamma scan profiles which could indicate missing or damaged trays. Tray 11 displayed a high erratic liquid level which could have been caused by tray debris from above.

The Gamma Scan data obtained correlated with the operational data of a low differential pressure and higher overhead temperature due to the missing trays allowing vapour to bypass quickly up the tower. The missing trays were responsible for the lack of liquid to vapour interaction resulting in poor amine quality leaving the regenerator.

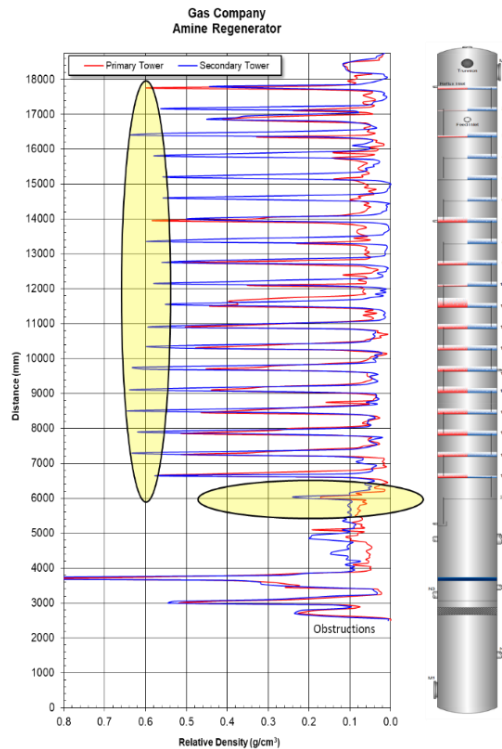
The Gamma Scan from the primary tower and the secondary tower were overlaid on the same plot for direct comparison. In contrast to the primary tower, the secondary tower showed most of the trays to be in position with consistent tray profiles, uniform liquid heights and good liquid to vapour disengagement between the trays.

Unexpectedly, the bottom most tray in the secondary tower was found to be damaged and not holding an aerated liquid level. This was identified by the low absorption profile compared to the trays above.
