CASE STUDY

Identifying Liquid Carry Over in a Glycol Contactor

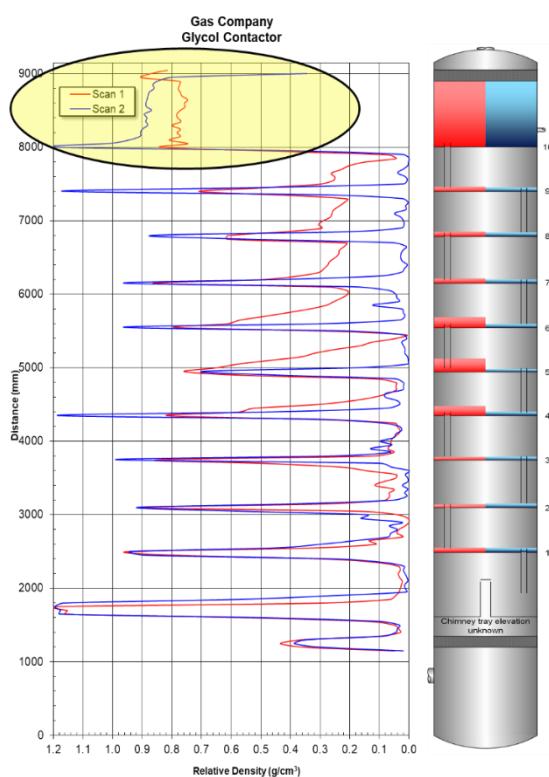
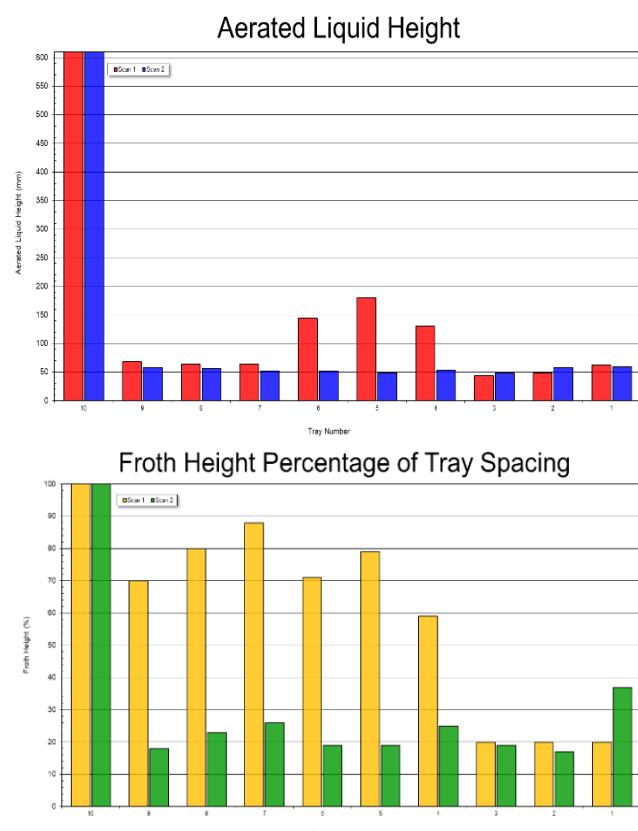
A non-invasive Gamma Scan was completed within an hour of starting the rig up. The results were immediately reviewed with the customer which showed that liquid was being held up on the top tray and was exiting the tower over head. The next 6 trays were showing indications of foam on top of the aerated liquid level and liquid droplets in the vapour space. The lowest 3 trays showed regular tray profiles.

As the top tray appeared to be liquid full, several scenarios were discussed with the customer:

- The downcomer could be blocked with debris preventing liquid from draining.
- The downcomer could be damaged resulting in a partially blocked downcomer
- Gas could be bypassing up the downcomer from damage, loss of seal at the tray below or a hole in the side of the downcomer.

The customer was able to bypass the gas flow through the tower and turn off the glycol circulation for a second scan. The tower was given 15 minutes to drain and stabilize before scanning. The second scan showed that the top tray remained liquid full with all other trays exhibiting regular unaerated liquid profiles at the height of the tray weirs. As the top tray continued holding liquid without gas flow, it was determined that the downcomer was blocked which was preventing the liquid from draining off the tray. Confident that the cause of the restricted fluid movement was a blocked downcomer and not physical damage, the customer ordered a new chemical wash on the tower with a different chemical to dissolve any solid material that had been brought in from the new wells.

- Gamma Scanning verified that the initial chemical wash done on the tower by the customer was not effective to completely rectify the problem they were experiencing.
- Gamma Scanning confirmed the problem to be a blocked downcomer near the top of the tower resulting in off-spec product being produced and shipped off at an increased cost.
