CASE STUDY

Flare Headers – What You Don't Know, Could Hurt You

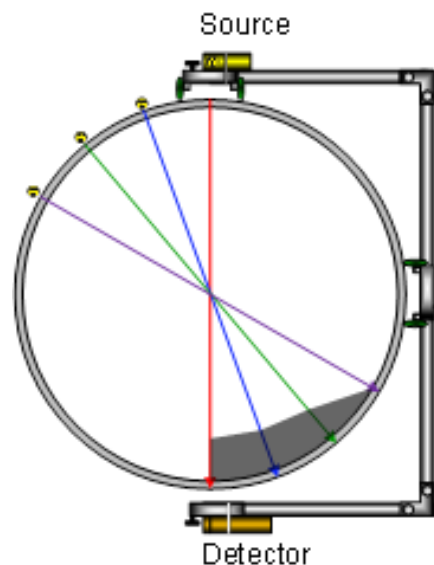
As the inspection technique is a through pipe service, orientations are generally chosen in the vertical and horizontal planes. If significant deposits are detected, a rotational scan is performed in this area to provide a cross sectional profile of the deposit.
