CASE STUDY

Identifying Liquid Carry Over in a Glycol Contactor

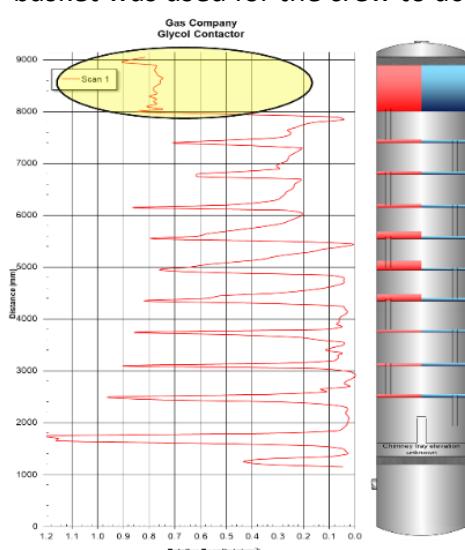
A non-invasive Gamma Scan was completed within an hour of starting the rig up. The results were immediately reviewed with the customer which showed that liquid was being held up on the top tray and was exiting the tower over head. The next 6 trays were showing indications of foam on top of the aerated liquid level and liquid droplets in the vapour space. The lowest 3 trays showed regular tray profiles.
